Name of Dam: Thelma Pitts Dam

Location: Caroline County, State of Virginia

Inventory Number: VA 03343

PHASE I INSPECTION REPORT NATIONAL DAM SAFETY PROGRAM

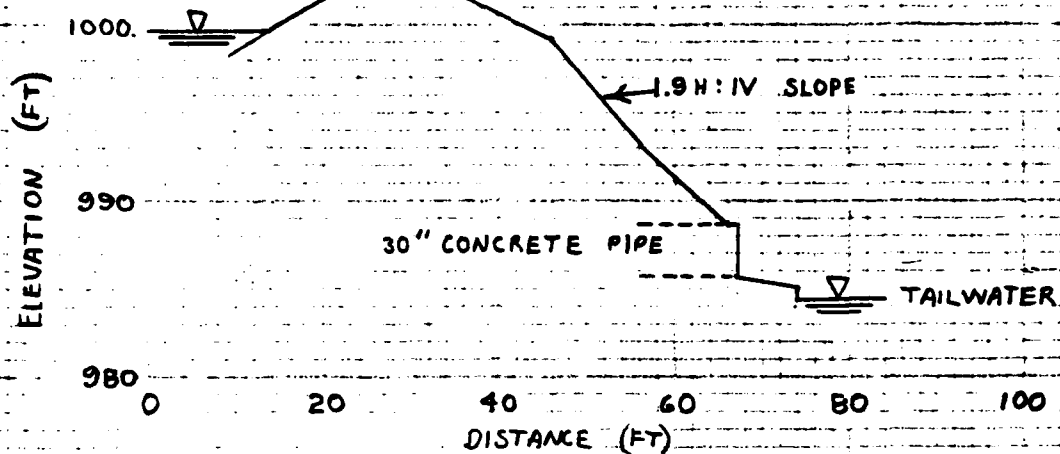
DAM CROSS SECTION AT OUTLET WORKS
STA 0+96

CREST WIDTH - 12 FEET

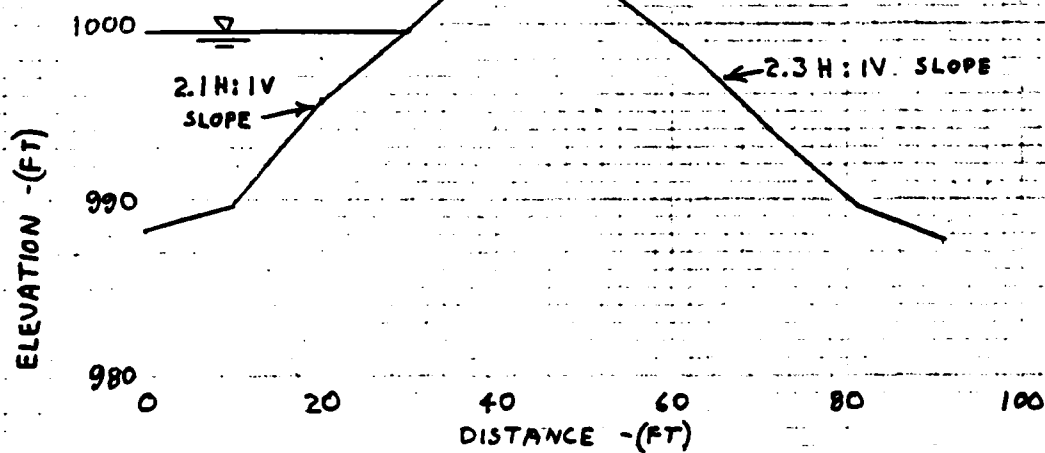
DAM CROSS SECTION STA 2+00

CREST WIDTH - 14 FEET
